STRUCTURE CONDITION REPORT

BARGE CANAL FAIRPORT-LOCKPORT

MATERIALS BUREAU

STRUCTURE CONDITION REPORT
BARGE CANAL - WESTERN SECTION
FAIRPORT TO LOCKPORT

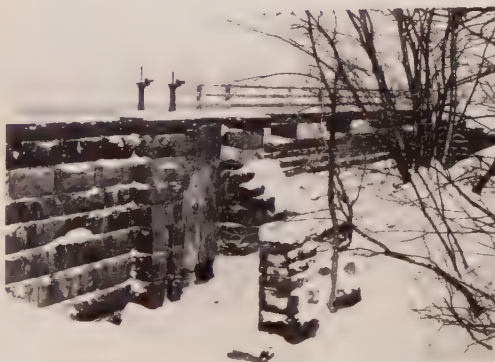
Looking East, Culvert 107 Entrance under wall in foreground, Waste Gate and Weir in background, Note new pedestrian bridge over weir.

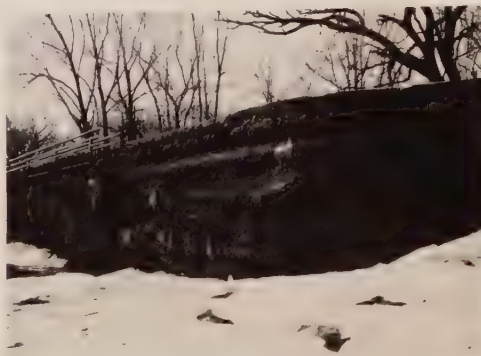
Canal Side, Looking East, Note concrete wall behind weir and shotcrete repairs.
Middleport Weir

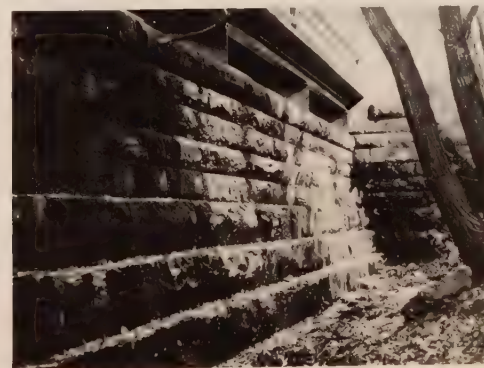
Looking East, Stone Masonry Weir, 1-Foot Thick Concrete Wall on Canal Side of Weir. Middleport Weir

The stone masonry weir was in good condition and had little seepage through it. Leakage through the high wall over the Culvert 107 entrance, however, was excessive. Measures to stop this flow and repair the Culvert 107 entrance are to be started early in 1977.

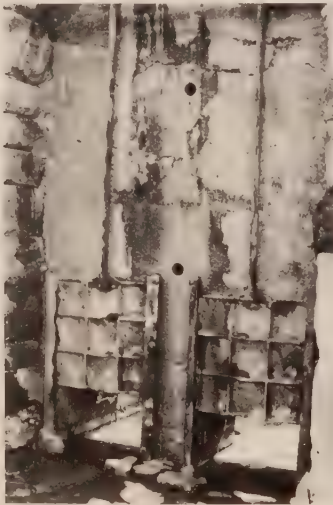
No shotcrete was placed on the concrete waste gate. Many cracks and some efflorescence were visible on this wall surface and approximately 60% of it sounded delaminated. Core #3, taken near the center of the wall, revealed rubble to a depth of 2 inches and cracking to a depth of 10 inches. Cores #1 and 2 were taken from the back or canal side of the 3 foot thick membrane wall and indicated deterioration to 6 and 8 inches, respectively.

Canal or North Side, Note core holes
#1 (bottom) and #2 (top).
Middleport Waste Gate

Repair of the waste gate should include patching or replacing the concrete lining in the openings which supports the doors. Region Canal Maintenance Personnel have scheduled this work to begin early in 1977 in connection with Culvert 107 repairs. These repairs should include the removal of all deteriorated concrete, or the complete replacement of this small concrete wall. We do not anticipate any other repairs at this time.

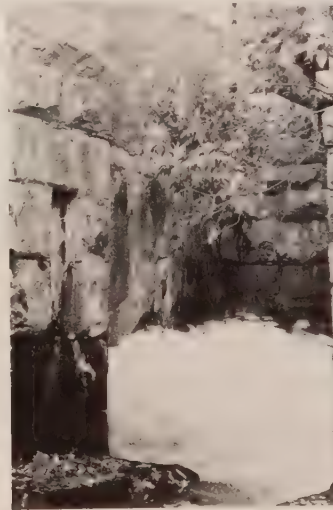
South Side, Note repairs to top of waste
gate behind branches. Middleport Waste Gate

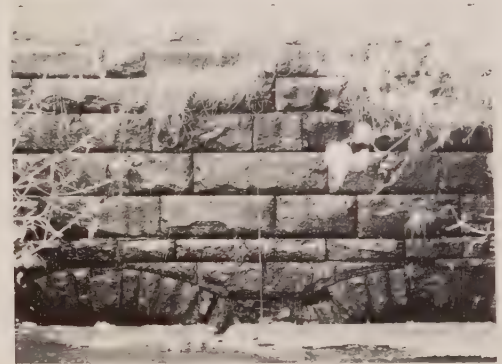
Stone Masonry Wall Over Culvert 107
Entrance, Creek Cascades Over Dam in
Foreground, Note leakage from arch stones.

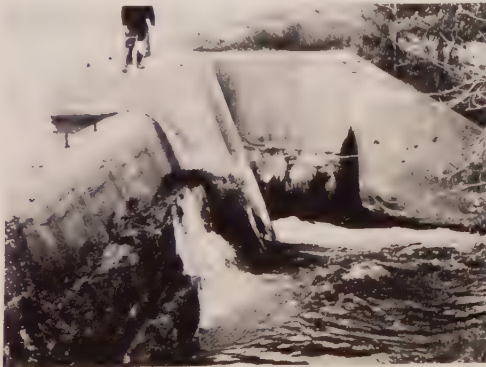
Looking East, East Abutment
Watsons Weir and Waste Gate

The construction joint also extended through the east abutment. The upper section of the wall was in generally good condition with light cracks at the top while the lower section exhibited delaminations on approximately 30% of its surface. The abutment wingwall was in generally good condition with light cracks at the top and bottom, but water was running freely from behind the wingwall. Sheetpiling has been driven behind the abutment in an attempt to cut off this water.

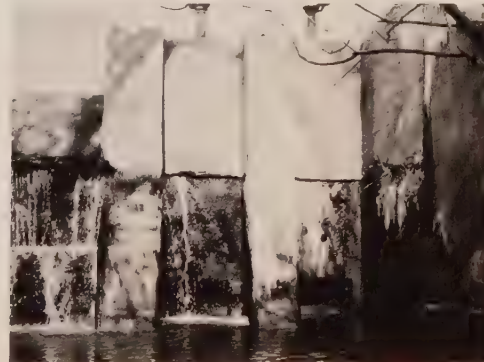
The top section of the waste gate, above the construction joint, was sounded and few delaminations were detected. This section also exhibited little or no cracking and scaling. The bottom portion of the gate sounded delaminated and exhibited cracks and scaling over approximately 25% of its area. Deterioration and leakage existed along the construction joint. Core #1 was taken from the front of the membrane wall below the construction joint. Slight cracking was observed to a depth of only 1 1/2 inches. This core had a compressive strength of 5815 p.s.i.

South Side, Note core hole #1
and horizontal joint.
Watsons Waste Gate

| <u>Core Number</u> | <u>Location</u> | <u>Scaled Depth</u> | <u>Deteriorated Depth</u> | <u>Intentional Breaks</u> | <u>Recovered Depth</u> | <u>Total Depth</u> | <u>Comments</u> |
|---|---|---|---|---|---|---|---|
| 1 | Waste Gate, South Side, Center of East Panel, 4½' From Bottom | 0 | 1½" | 0 | 12" | 12" | Solid sounding area. |

Although heavy leakage was occurring through the construction joint, this structure was basically sound. The construction joint through the waste gate and weir should be sealed to prevent further deterioration. The top section and other areas of the weir containing deterioration should be removed and a new top and front face of the weir bonded to the existing sound concrete. Other deteriorated areas of the abutments and waste gate should also be repaired and leakage from behind the east abutment should be cut off.

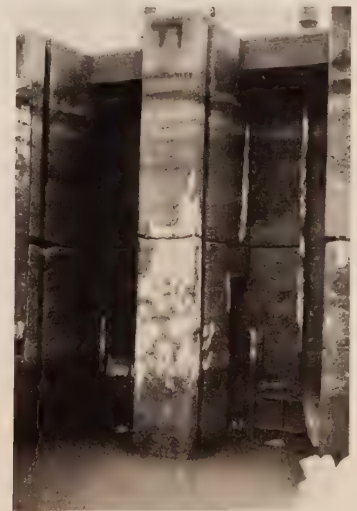
The buttresses were in much the same condition as the membrane wall. The upper parts of the buttresses were in good condition and the lower sections below the construction joint showed cracking and delaminations. Leakage of water through the construction joint has caused the bottom section of this structure to deteriorate much more rapidly than the top section. Little difference in concrete quality was evident between the top and bottom sections on the canal side of the structure.

North Side, Note horizontal joint.
Watsons Waste Gate

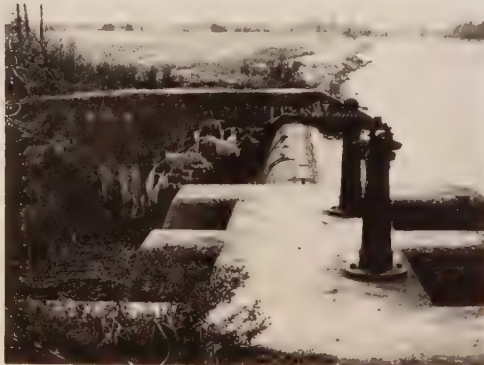
Looking West, West Abutment
Watsons Weir and Waste Gate

The west abutment exhibits light cracking and efflorescence over half of its surface, but sounding revealed little delamination.

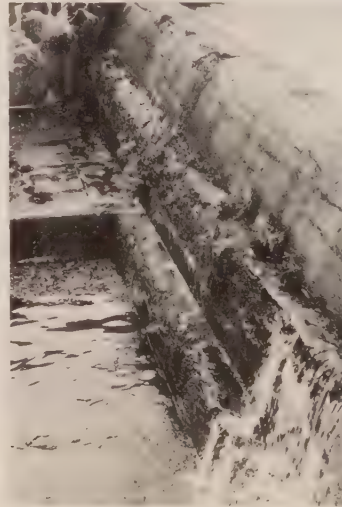
Much leakage through the construction joint was also occurring along the weir, especially at the east end. Delaminations were detected on approximately 30% of the top 3 1/2 feet of the weir. Scaling up to 1 1/2 inches in

depth was also present. The bottom section of the weir also exhibited scaling over most of its surface. As with the waste gate, this form of deterioration was attributed to leakage of water through the construction joint. Soundings revealed delaminated areas covering 20% of its surface. Core #2, taken from the front of the weir in a scaled area below the construction joint, indicated deterioration 5 inches deeper than the 4 inch deep scaling present on the surface. Much of the area behind the weir has been backfilled.

South Side
Watsons Weir

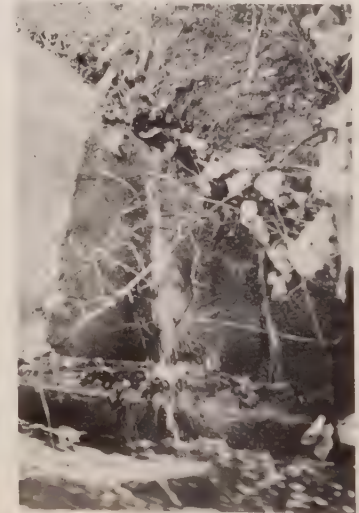
Leak From Behind East Abutment
Watsons Waste Gate

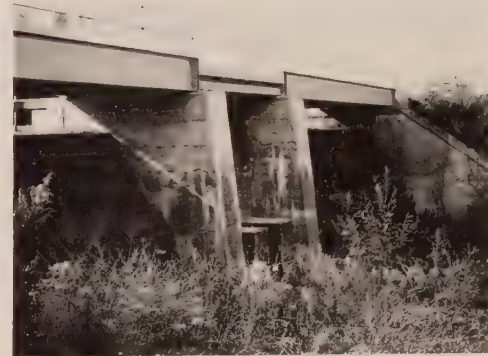
North Side
Gasport Weir and Waste Gate

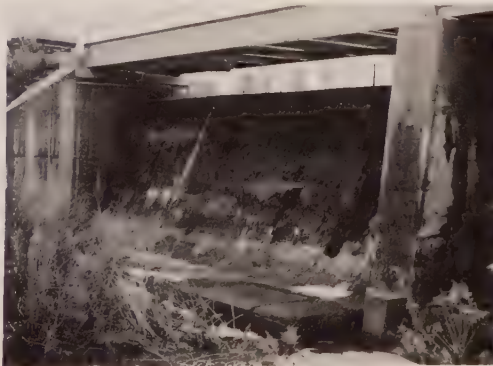
East Half of Weir
Gasport Weir and Waste Gate

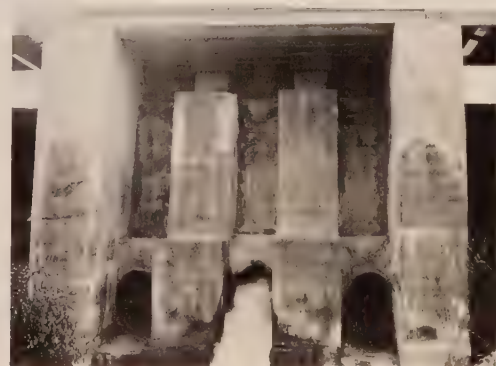
North Side
Gasport Waste Gate

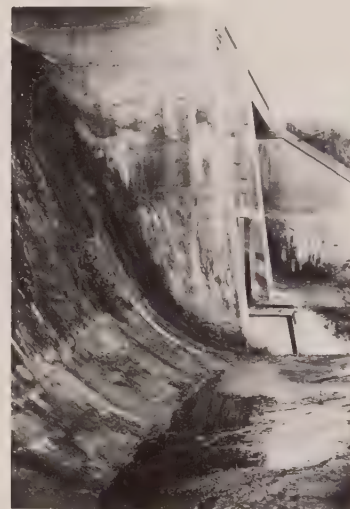
Looking West, Note repaired west abutment and piers. Gasport Weir and Waste Gate

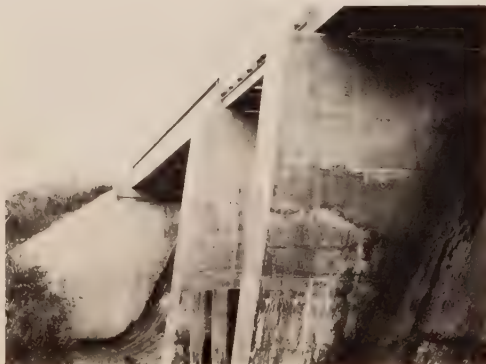
Looking East, Note repaired east abutment and piers. Gasport Weir and Waste Gate

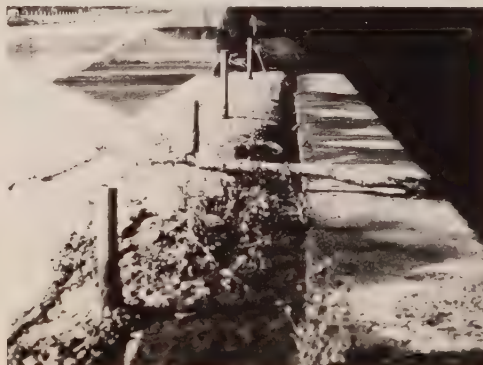
Looking West, Note new facing on both sides of weir. Gasport Weir

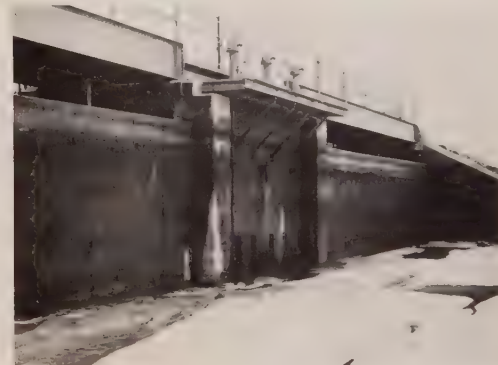
Canal or South Side Gasport Weir and Waste Gate

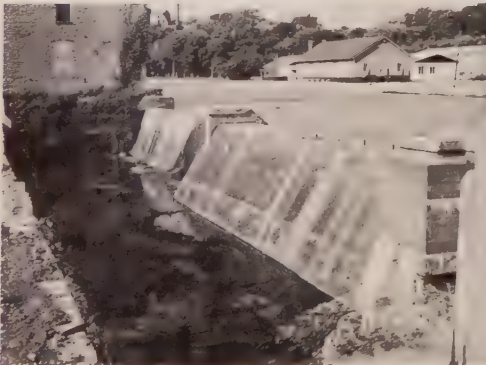
Looking West, Note new repairs on west half of weir. Lockport Weir

During the Winter and Spring of 1976, a 40 foot long deteriorated section was removed from the crest of the west half of the weir. Sound concrete was encountered at a keyed construction joint approximately 2 feet below the crest and a new concrete crest was bonded to the existing concrete. However, isolated areas of deteriorated concrete still exist on the weir face below the repair. Core #1, taken from the front of the weir in a delaminated area, revealed deterioration to a depth of 6 inches.

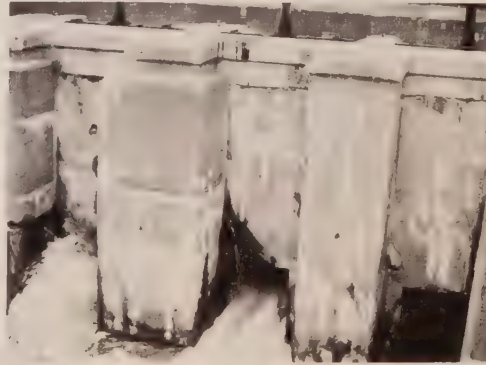
South Side, Concrete Encased Stone Masonry Walls. Lockport Waste Gate

The concrete encasement of the stone buttresses was distressed. The west buttress had approximately 8 inch deep deterioration. 4 to 5 feet above the foundation and much leakage was apparent through the encasement. The center and east buttresses had cracks and efflorescence over 50% of their surfaces. The center buttress encasement has split away from the membrane wall and a large quantity of water was leaking through this crack. Core #2, taken from the center buttress and through the concrete encasement, revealed deterioration of the concrete to a depth of 6 inches. Water ran freely from the core hole after the core was removed. The sluice gates either could not be completely closed or were inoperative.

Future restoration of the waste gate should include removal of the concrete encasing the buttresses and removal of all deteriorated concrete in the membrane wall. Then the entire waste gate should be encased in concrete.

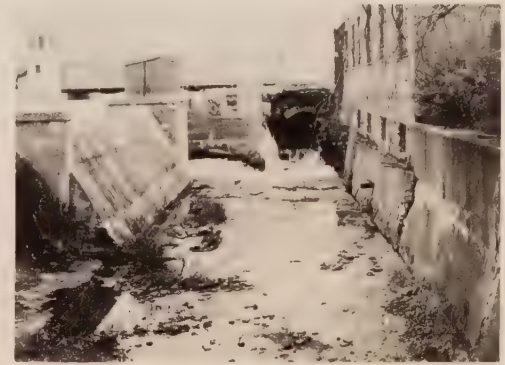
Looking East, 1975
Lockport Weir and Waste Gate

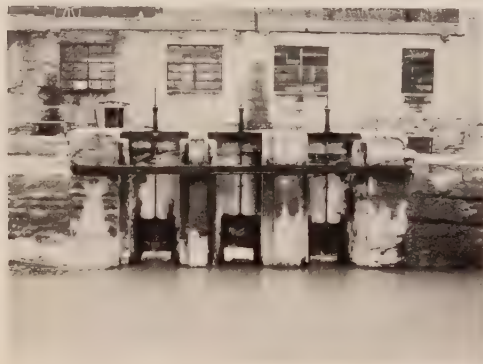
Canal or North Side, Note stone masonry wall over Culvert 125 at left.
Lockport Weir

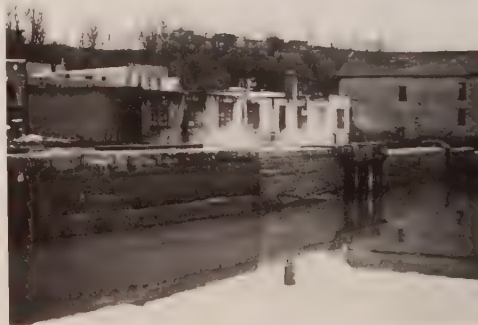
Canal or North Side, Looking Southwest
Lockport Waste Gate and Weir

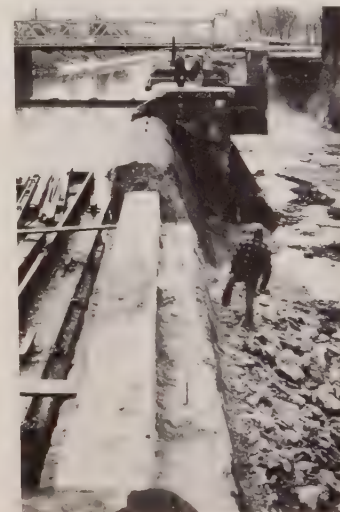
Looking East, 1976 Repairs to Weir,
Note shape of notch on top of weir.
Lockport Weir

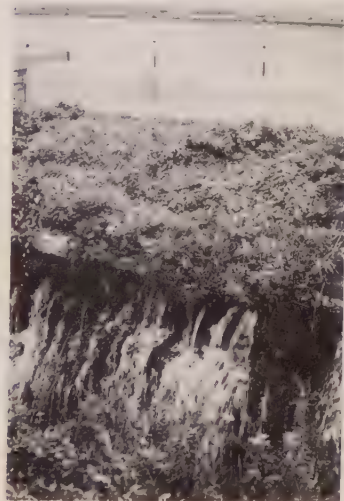
Recently Canal Maintenance Personnel have replaced the concrete cap of the east stone weir in an attempt to stop a large quantity of water which cascades out from the front side of the stone blocks and down into the entrance of Culvert 125. Also, a clay cutoff wall was placed behind the concrete faced, stone block masonry retaining wall extending east toward Exchange Street and the wall surfaces were patched. However, the leak continued when the canal was refilled.

Leak Over the Top of Culvert 125
Lockport Weir

The heavy leak existing over the top of Culvert 125 should be located and sealed.

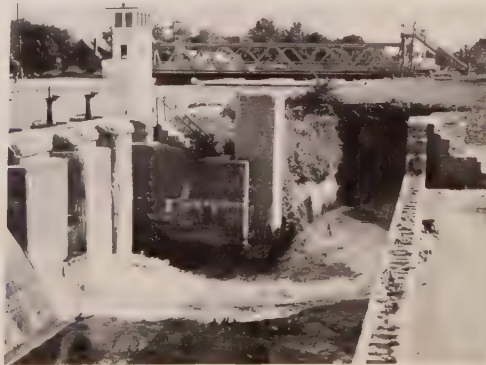
Looking East, 1976. Note removal of shed
over gates, removal of garage on right,
and leak over Culvert 125 entrance.

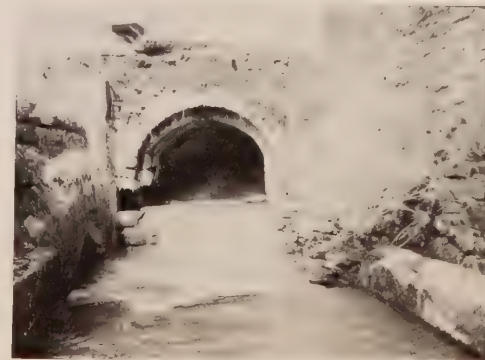
Culvert 125 Entrance at Lower Left, 18 Mile
Creek Culvert Exit in Center. (Note missing
lower left corner of arch.) Lockport Waste Gate

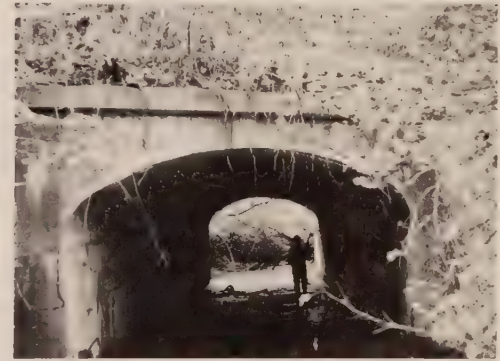
Old Railway Culvert Next to Holley Weir

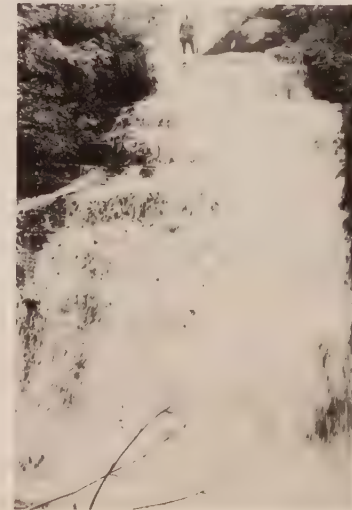
Holley Waterfall Downstream From Holley Weir

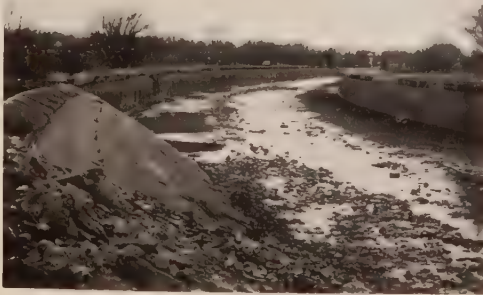
Looking West from East End
Holley Trough

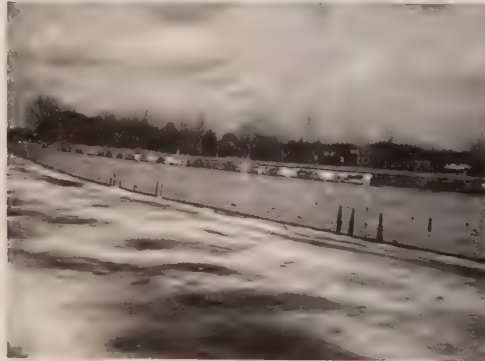
The north trough wall is composed of 40 panels plus the two end splaywalls. From east to west, the first 21 panels were in good condition with no detectable delaminations. On the 22nd panel, the east half was in good condition whereas the west half was 75% delaminated and contained a 3 inch wide by 6 inch deep by 7 foot long area of concrete scaling near the bottom of the wall. Between the 23rd and 40th panels, six panels contained no detectable delaminations, one panel was 50% delaminated, eleven contained between 5-20% of their surface area deteriorated and the west splaywall was 80% delaminated. Six additional areas of deep concrete scaling were seen on three panels. These scaled areas most likely have resulted from pockets of honeycombed (lack of consolidation) concrete.

North Wall, Looking West from near East End
Holley Trough

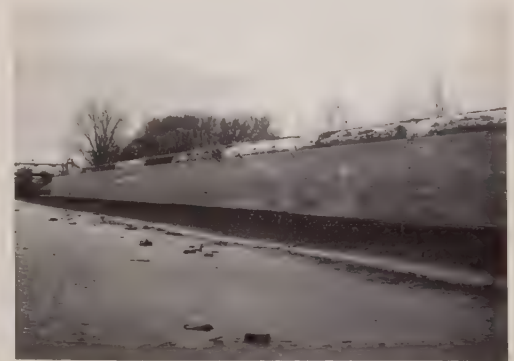
Looking West, West End of North Wall
Holley Trough

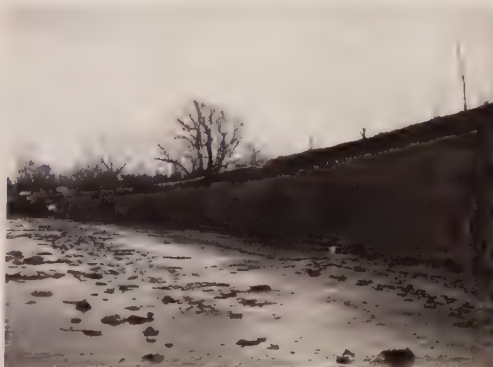
The eastern third of the south wall (panels #19-30) and the Holley Waste Gate and Weir were constructed with concrete containing crushed Medina sandstone coarse aggregate. These concrete areas generally appeared to be in poor condition. Although panel #19 contained no detectable delaminations, panels #20-30 contained major deterioration ranging from extensive delaminations to the top third of the wall falling into the canal. Some of these panels were too dangerous to walk under as the walls had cracked horizontally 3-6 feet below the top and moved inward about 1 foot. Depressions up to 3 feet deep existed in the embankment directly behind the wall. Previous concrete repairs and sections of the wall have fallen into the canal and other pieces were now loose and ready to fall.

East End of South Wall
Holley Trough

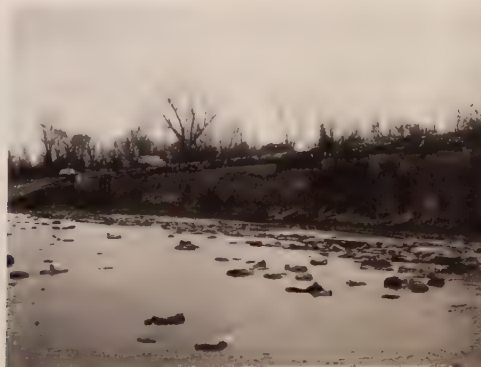
East End of South Wall
Top of Wall Falling Into Canal
Holley Trough

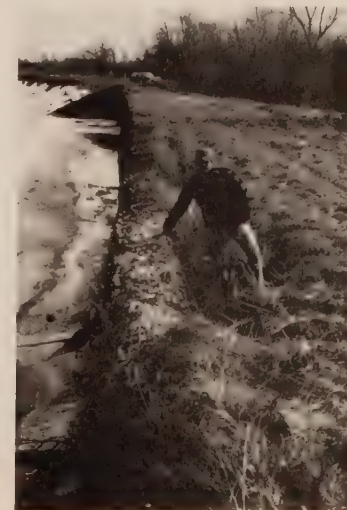
Looking East, East End of South Wall
Note depressions behind wall
Holley Trough

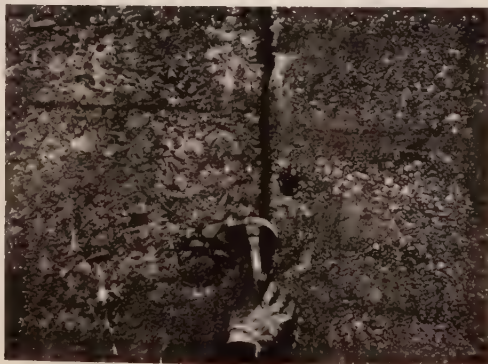
South Wall, Two Types of Aggregates
Medina Sandstone on Left, Gravel on Right
Holley Trough

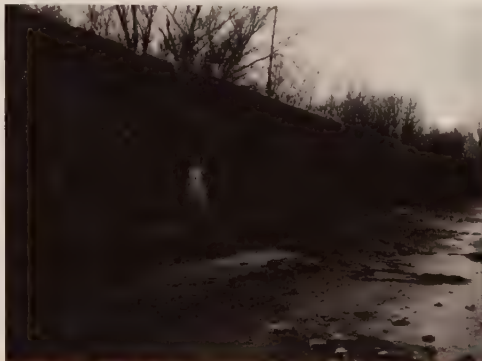
Of the 1st 18 panels of the south wall (from west to east), 8 contained no detectable delaminations, 5 were 30-50% delaminated, and 5 were 5-20% delaminated.

West Half of South Wall, Looking West
Holley Trough

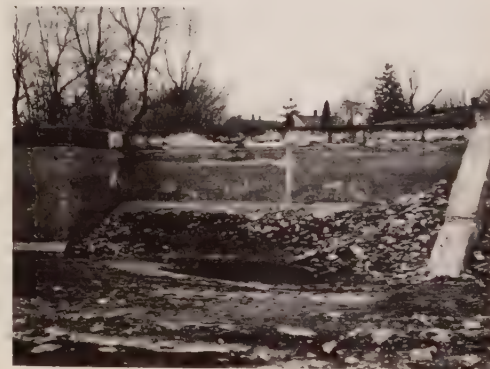
In 1919, under Contract 200, the top of the Holley Spillway was raised 3 feet with concrete to eliminate any water from flowing into the abandoned Erie Canal channel. This top 3 feet is now 100% delaminated while the spillway wall underneath is still in relatively good condition.

Holley Spillway at West End of South Wall
Note 3 foot cap on top of old spillway
Holley Trough

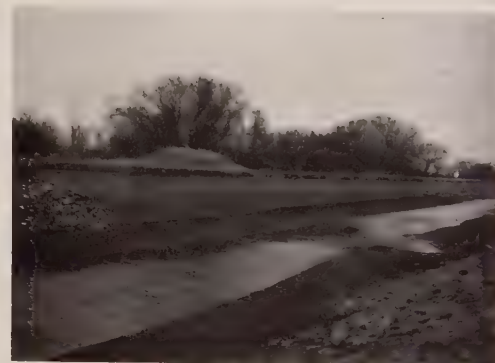
North Wall, Looking East
Eagle Harbor Trough

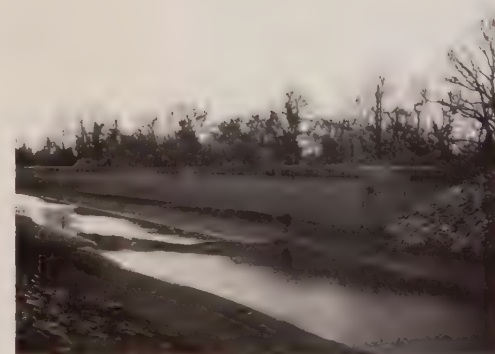
North Wall, Looking West
Note sheet piling protruding above water.
Eagle Harbor Trough

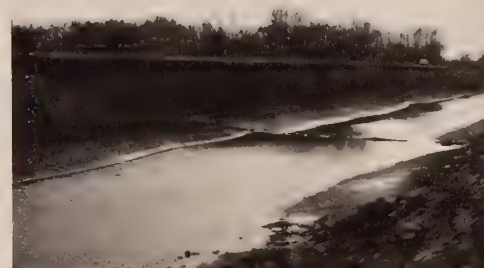
South Wall, Looking West
Eagle Harbor Trough

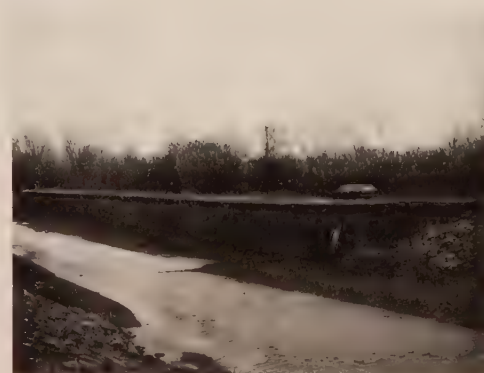
South Wall, Looking East
Eagle Harbor Trough

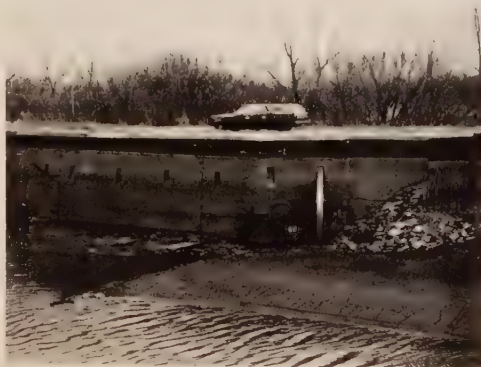
What was of present concern, however, was a 1 foot wide by 10 foot long hole which extended under the corner splaywall. In front of this splaywall, the trough floor (covered with water) had dropped over 2 feet lower than that at the center of the trough. Although both ends of the trough had been sheetpiled, no sheetpiling was seen behind the walls and there was the possibility that water could be leaking under the wall or down through the floor and out the embankment. An inspection of the embankment in this area revealed no sign of any past or present leakage.

Southwest Corner, Area of 1927 Failure
Eagle Harbor Trough

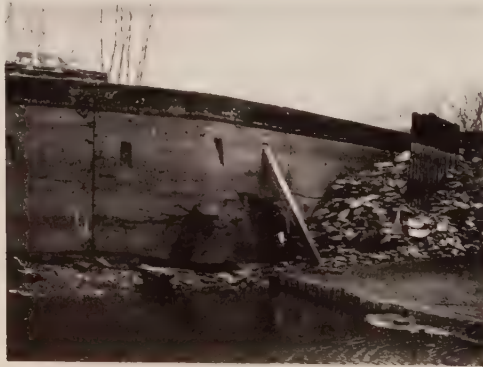
Southwest Corner, Note anchor bolt heads 2 feet below top of wall and large hole under corner wall. Water covered floor drops 2 feet by sheet piling.

Since no mention was made of the anchoring system, this work must have been done later. The anchor rods were located about 2 feet below the tops of the wall and were undoubtedly attached to the sheetpiling driven behind the walls in the embankment. Presently, however, the ends of some of the anchor rods have rusted so seriously that the anchor rod heads have fallen off.

The Eagle Harbor Trough still is in good condition, except for the area that failed in 1927. As the anchor rod heads fall off, this short section of wall could start moving inward due to soil pressure behind the wall and the presence of more voids underneath or an unstable foundation. This area needs watching and possible repairs.

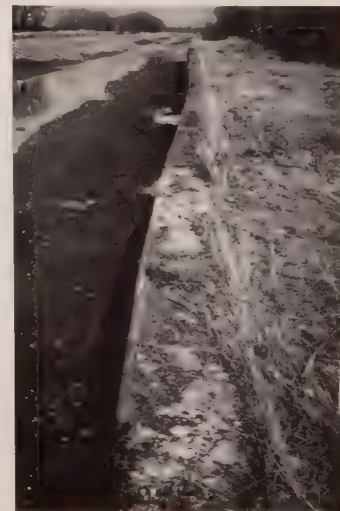
Looking East along South Wall from West End
Note inward movement of wall in foreground

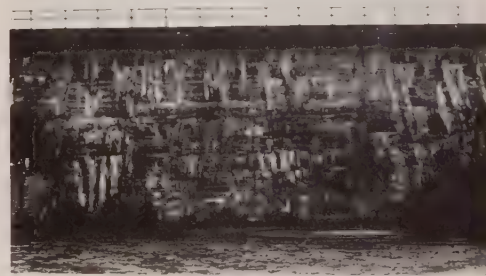
North Side of Trough Wall West of Culvert 99
Surface cracked and stained. West of this
area, the north wall is mostly obscured by
trees and underbrush.

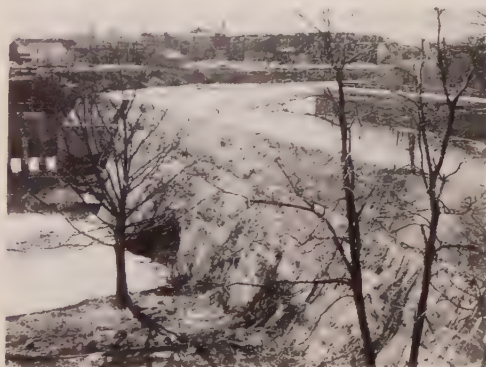
Looking West Along South Trough Wall
Culvert 99 Entrance at bottom of wall. Surface cracked and stained.

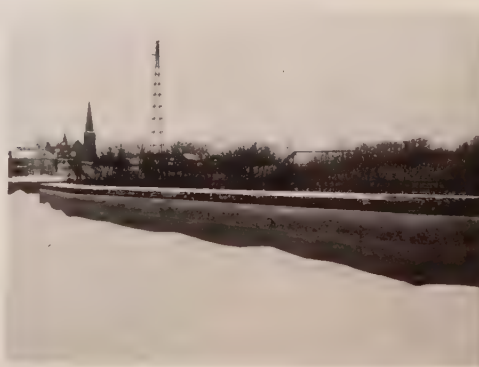
The inside wall faces also appeared in good condition, but nearly all wall panels had 1 or more long, narrow areas of up to 1 foot deep scaling. These areas followed horizontal construction joints or cold construction joint lines on the walls. Due to the generally sound appearance and massiveness of the high walls, no cores were taken.

South Face of Trough North Wall
Horizontal deep scale areas and joint lines along wall. Medina Harbor at left. Medina Gorge beyond wall on right.

Except for pockets of scaling on the insides of the trough walls and surface scaling on the outsides, the walls appeared to be in good condition. No repairs other than to possibly small areas of deterioration are anticipated. However, most wall surface areas could use a durable cosmetic treatment to eliminate the unsightly scalings.

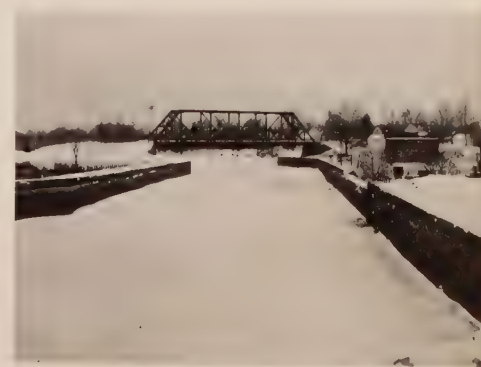
Looking East From Medina Harbor
Medina Weir and Waste Gate on right. Note deep scale areas along both walls.

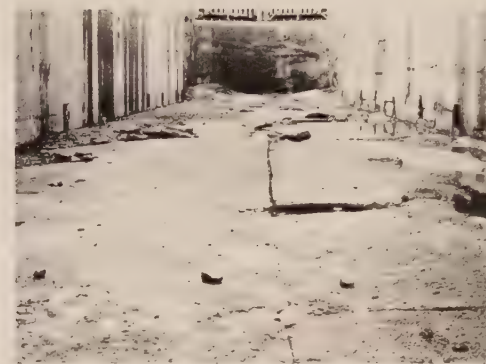
The floor of Lock 35 appeared to have buckled from extreme pressures. Concrete slabs were cracked and tilted throughout. Some slabs were nearly 2 feet above others and numerous 1 foot deep holes existed. Also, it appeared that some damage had been caused by extreme turbulence on the lock floor. At a few of the port openings, 8 foot square concrete pads had been placed in the concrete floor. According to Region personnel, the floor of Lock 34 is similar to Lock 35.

Looking West - Lock 35 Buckled Floor

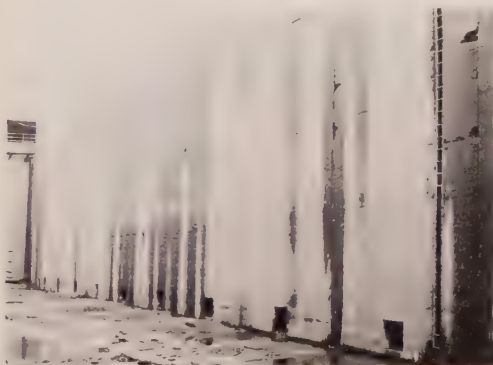
South Lock Wall - Lock 35, Looking East
Note lack of extensive deterioration

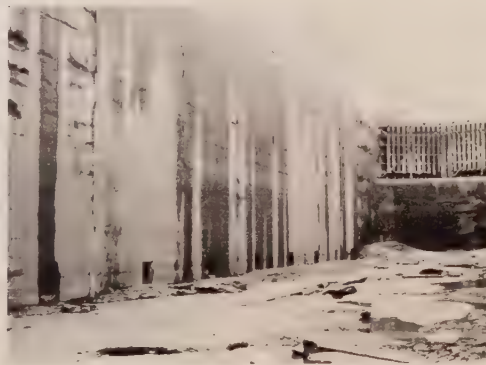
The deterioration on the Lock 35 walls appeared to be concentrated in isolated sections. On the south wall, the majority of the deterioration was on the 2 wall panels at the west end of the lock. This section was rebuilt in 1920 under Contract 152. Another area of deep scaling had occurred near the bottom at the east end, where the wall is recessed to receive the opened lock door. The remainder of the south lock wall contained only a few scattered scaled areas. These areas of deterioration were in the vicinity of either cold or lift joints on the concrete walls.

South Lock Wall - Lock 35, Looking West
Note deterioration at west end and buckled floor.

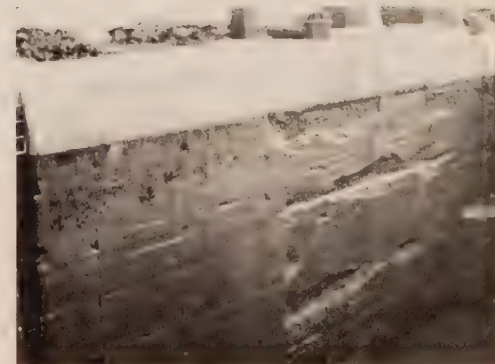
West End of South Lock Wall - Lock 35
Deteriorated areas were rebuilt in 1920

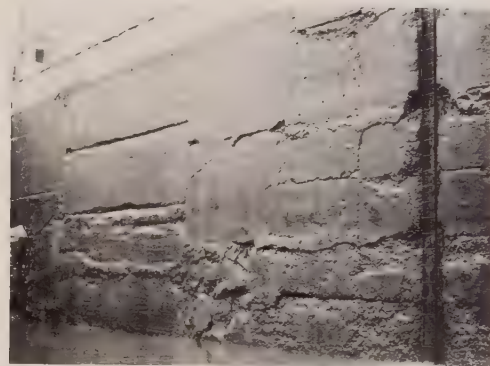
West End of North Wall - Lock 35
Block 68 located in center of photo. Note cracks and repair failures. This area was rebuilt in 1920.

The remains of grout or shotcrete repairs can still be seen clinging to some of the deeper scaled areas next to and on block #68 at the western end of the north lock wall. These repairs may have been made under Contract 152 (Alteration #1) in 1920, but they most likely are of a more recent vintage. Since 1920, repairs have also been made on the concrete sills at both ends of the lock by Canal Maintenance Personnel.

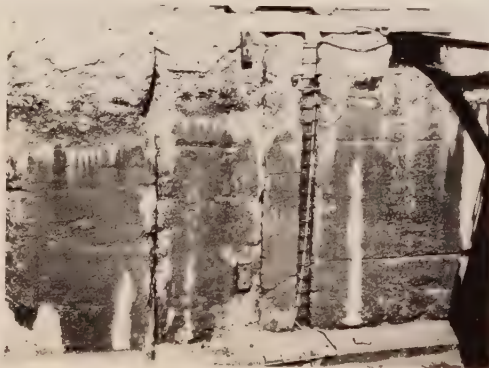
North Wall Between Upper Lock Doors

Between the 2 sets of upper lock doors, the concrete walls have scaled over most of their surface area. These walls were also rebuilt in 1920. Some recent repairs have been made along the top of these walls.

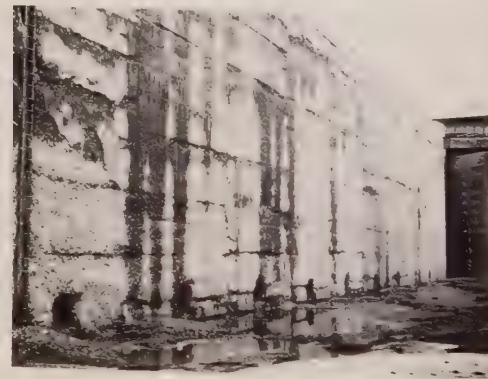
North Wall - Lock 35
Note change in surface deterioration halfway along wall

Although no additional cores were taken from the north lock wall, the west half (except for the 1920 rebuilt west corner) appeared to contain concrete with crushed stone aggregate. The concrete performance contrast between the gravel aggregate concrete used in the east half and the crushed stone aggregate used in the west half was very apparent at the vertical joint between port holes #4 and 5 (from eastern end of lock).

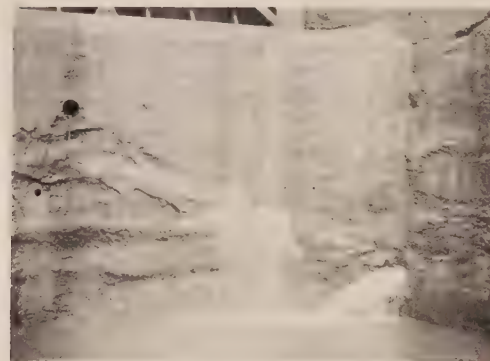
On September 22, 1976, five cores were obtained from the western end of Lock 35 where the majority of the deterioration existed. Core #3 was taken from the concrete sill below the recently repaired top. This 1920 rebuilt area contained deterioration 11 inches deep and the bottom section of the core had a compressive strength of 5915 p.s.i.

West Sill of Lock 35
Note core hole at left center (upper hole is drain) and leak through lock wall at right.

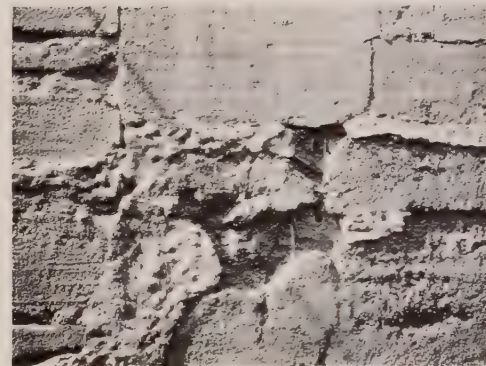
On the north lock wall, Core #1 was taken in the upper west corner just above the high water level mark. This 1920 rebuilt area contained deterioration only 3 inches deep. Core #2, 27½ inches long, was taken in a 6 inch deep scaled area where the surrounding concrete contained partially missing repair patches. This core was obtained along either a horizontal cold joint or crack, which had filled in with mineral deposits. The last 6 inch section of this core was limestone block. (Limestone blocks from the previous Erie Canal lock walls were probably used as fillers for the new Barge Canal concrete lock walls).

The area represented by Core #2 was block #68, supposedly rebuilt in 1920 under Contract 152 (Alteration #1). However, other rebuilt areas contained gravel coarse aggregate concrete while Core #2 contained concrete with crushed limestone coarse aggregate. This may indicate that block #68 was not rebuilt as shown on the contract plans, but only repaired. Therefore, Core #2 probably represents the original 1912 construction.

Block 68 - Lock 35
Area of Core #2. Note core hole.

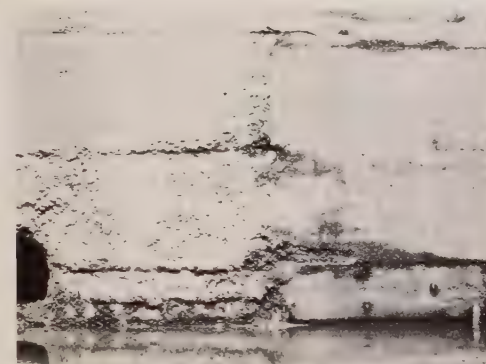
Joint Near Middle of Lock 35 North Wall
Crushed limestone aggregate concrete on left. Gravel aggregate on right.

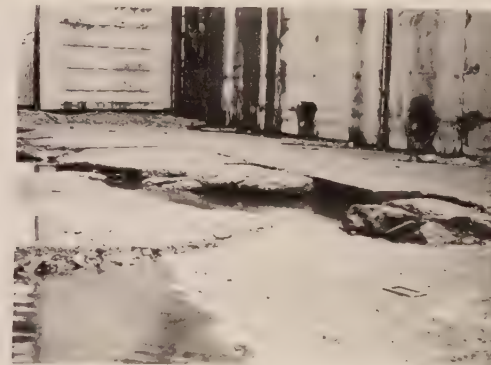
Buckled Floor of Lock 35
Note scaling at right of southeast door
and broken floor slabs.

The reason for the apparent differences in deterioration within Lock 35 and between Lock 35 and Lock 34 is not presently known. However, Lock 34 is still in relatively good condition and only isolated repairs are needed. Lock 35 contains isolated areas of deep scaling and delaminations. The majority of the deterioration is presently contained within 15 inches of the original surface. Due to the thickness of the massive lock walls, this noted deterioration is a surface condition which detracts only from the aesthetic value of the structure. Areas of deeper deterioration exist in the area of block #68 and in other small isolated areas which can only be located as future repairs are made. Open vertical joints in the lock walls should also be sealed to prevent leakage into and out of the lock.

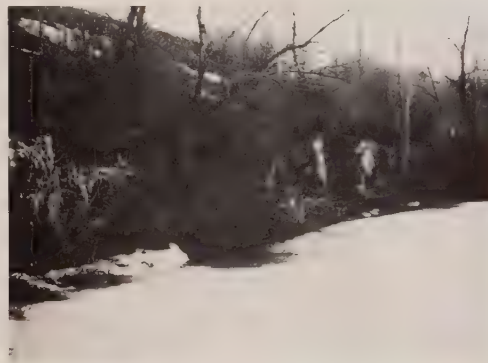
West End of Quarry Wall
Due to a number of leaks into the quarry, this wall
was constructed when the Barge Canal was built.

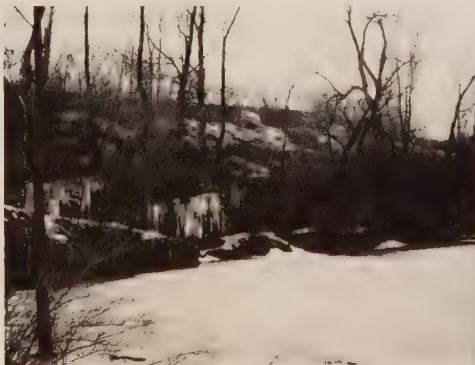
East End of Quarry Wall
The wall was inspected in the Winter 1976 when the
canal was empty. No cores were taken. Quarry
depth is not known.

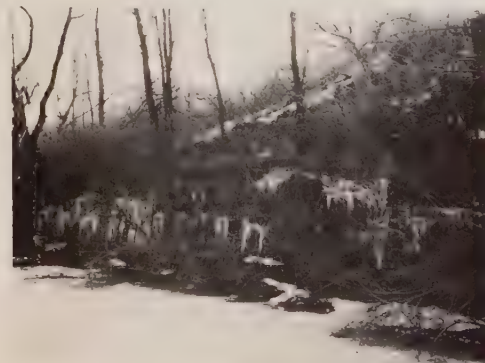
Center of Quarry Wall
Although the wall surface contained a number of
efflorescent covered cracks, the concrete appeared
to be in generally good condition.

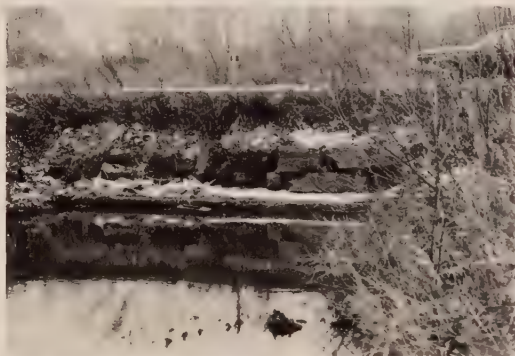
Exit
High Water Covered Headwall

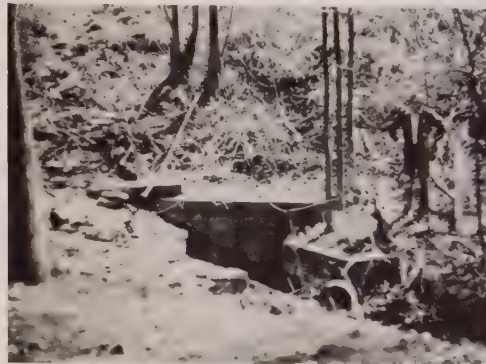
Exit
Concrete headwall was in good condition.
After cleaning by Canal Maintenance Forces,
first 12 feet at exit was inspected, but
rest of pipe was half full of mud.

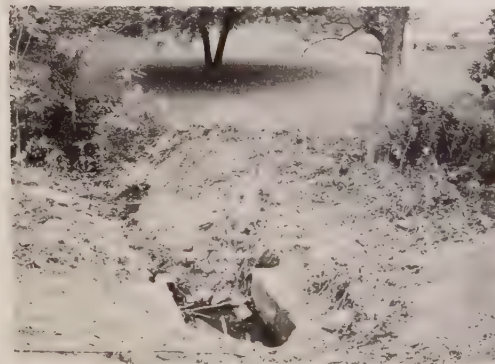
Exit area after embankment cleared for widening
in 1976. Culvert is to be lengthened. These
deep culvert wells present hazards to children in
residential areas.

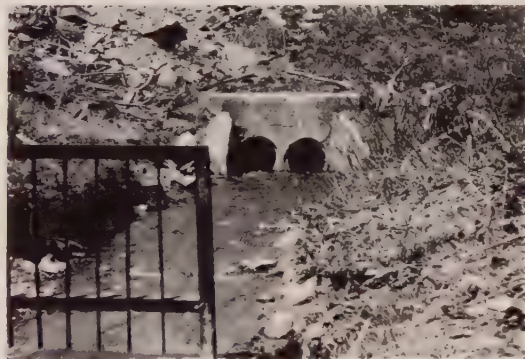
Entrance

Trash rack in foreground. Some localized deep scaling on headwall, but generally in good condition.

Cast-iron culvert was in good condition. Some seepage noted at nearly all joints.

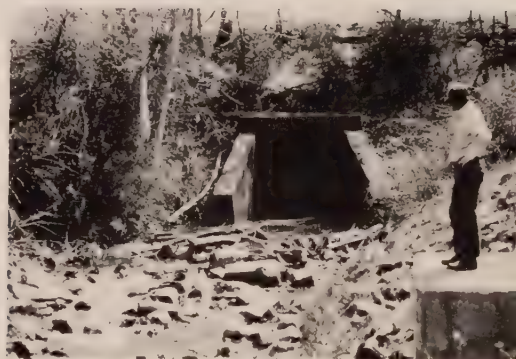
Old Exit

Deep scour hole at exit. Headwall area in good condition. Sewer crosses stream in foreground.

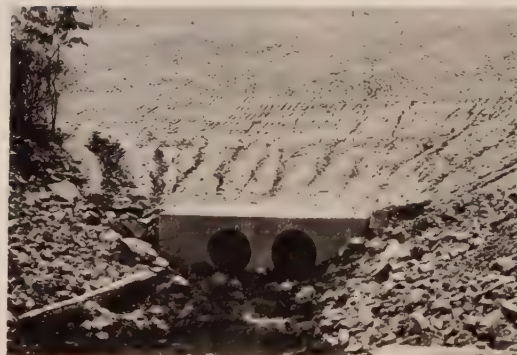
New Exit

In 1976, embankment was widened and culvert lengthened. Light snow on ground.

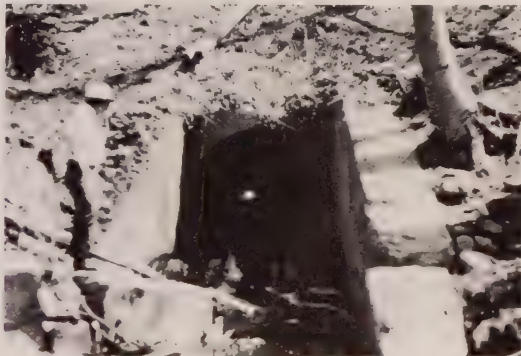
Exit

Entrance and exit headwall areas and culvert never thoroughly inspected. However, all joints in the cast iron lining, as seen from both ends, were heavily coated with mineral deposits. This means slow seepage through the joints.

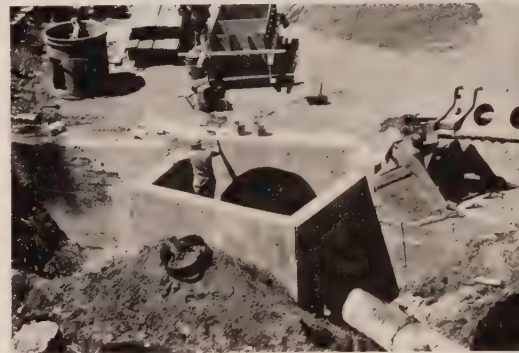
Entrance under Construction

Concrete wall around entrance restricts flow to two 30" openings until water rises over top of wall.

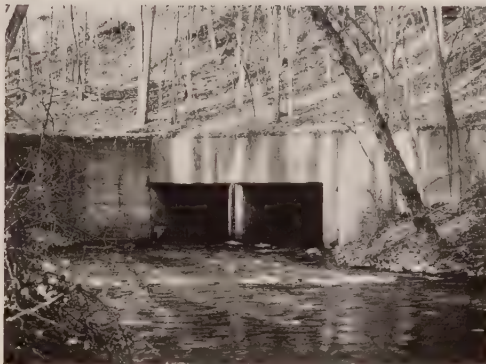
Entrance
Headwall and wingwall areas in good condition

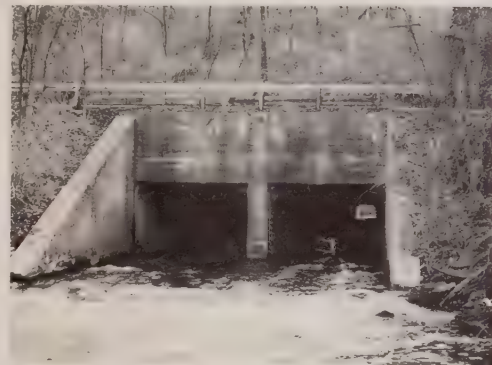
Exit
Deicing chemicals and freeze-thaw action have caused cracks and scaling on top of headwall. Wingwalls in good condition, except for a few cracks at the ends.

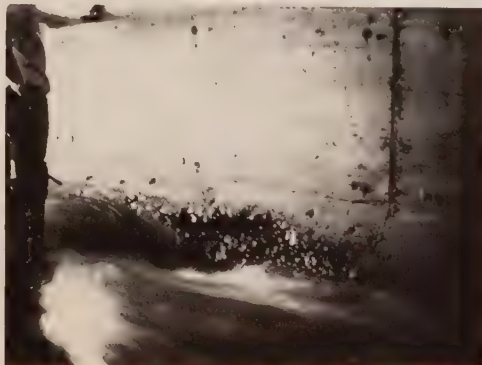
Deep eroded or honeycombed area at south end of west barrel

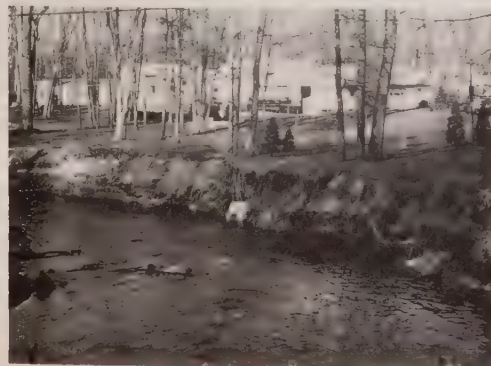
Looking Downstream from Exit
Note bank erosion and attempts to stop it.

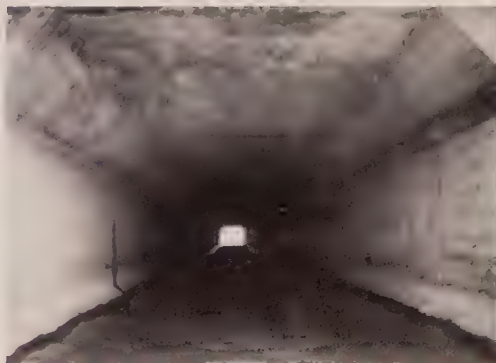
East Barrel - Looking South or Upstream From Exit

One construction joint near middle of barrel open 3/4-1". Joints mainly near barrel ends have a little seepage. Very little seepage elsewhere. Most seepage starts a foot or two above triangular concrete floor corners. Many isolated areas where concrete cover has popped off due to rusting "high" steel. A few bars were heavily rusted. 1' x 2' eroded or scaled area 50' from south end or entrance on west wall. Barrel generally in good condition.

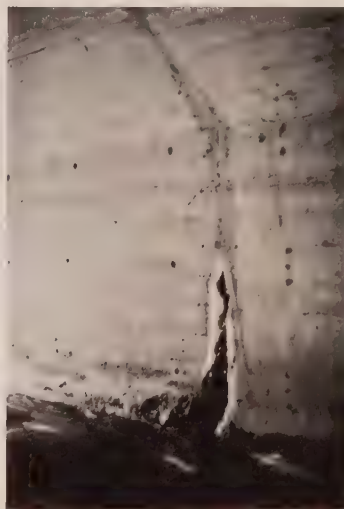
South End of West Barrel
Slow seepage at scaled or
eroded joint area.

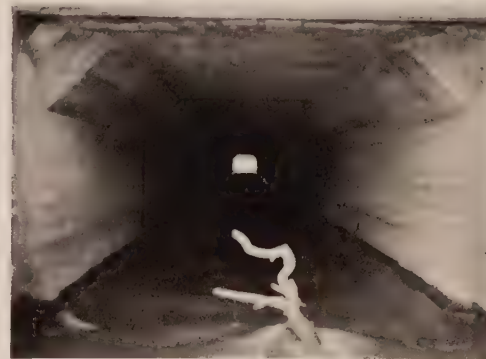
West Barrel - Looking South or Upstream From Exit

One construction joint near middle of barrel open 3/4-1". Two deep scaled or eroded areas - 4' x 5' area and 1½' x 30' long area on east wall 150' from south end or entrance. These eroded areas may have been honeycombed areas that were patched during construction and have scaled away. Many isolated areas where concrete cover has popped off due to rusting "high" steel. A few bars were heavily rusted. Barrel generally in good condition.

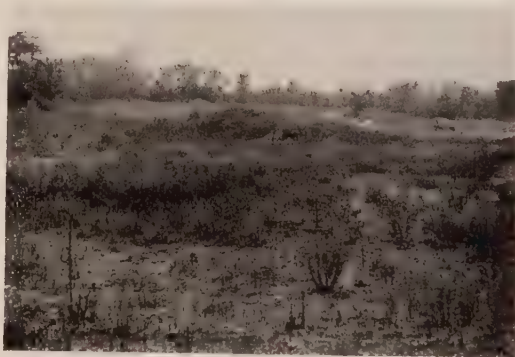
Entrance in Foreground under Sanitary Landfill

On the north side of the canal at the west end of the Irondequoit Trough is the Town of Perinton Sanitary Landfill Site. It is doubtful whether anyone discovered the culvert entrance prior to land fill operations as it would have been hidden by brush.

A thorough search was made for the culvert exit (6" cast iron pipe encased in 1' of concrete) on the south side of the Irondequoit embankment at the toe of slope, but only an old roadway culvert drainage channel with a concrete endwall was found.

The culvert no longer serves any purpose and should be well protected in the embankment from deterioration. However, this culvert should not be forgotten as it is still a hollow structure capable of carrying water.

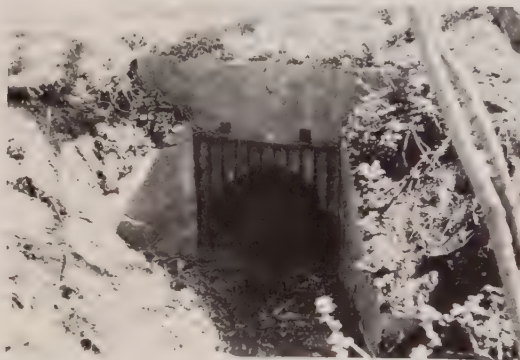
Entrance

Headwall and wingwalls were in fair condition. There were many cracks, but the concrete sounded solid.

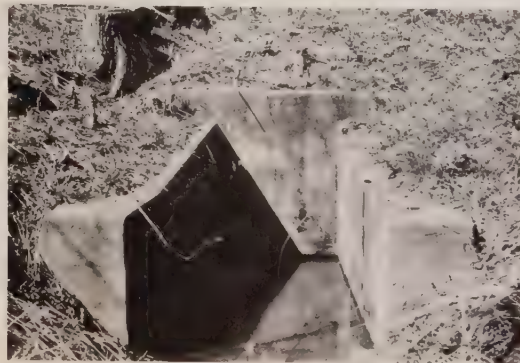
Exit

Headwall and wingwalls in good condition, except for many cracks on right wingwall.

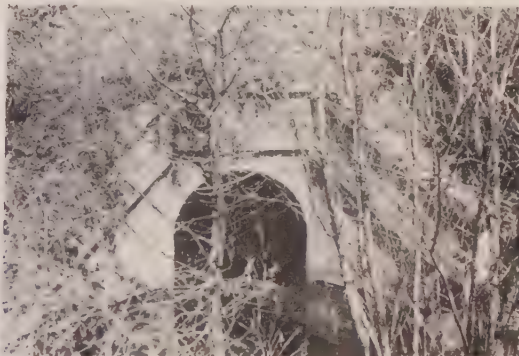
Entrance

This is the entrance to the railroad culvert. After approximately 75', the floor slopes down and the canal culvert begins. The stone block arch railroad culvert and the beginning of the canal culvert appeared in good condition. Some heavy seepage was occurring at the joint between the two sections.

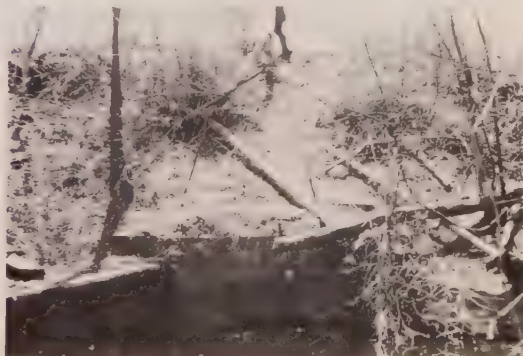
Exit

Headwall and wingwalls appeared in good condition. In 1976, this end of culvert is to be lengthened due to embankment widening.

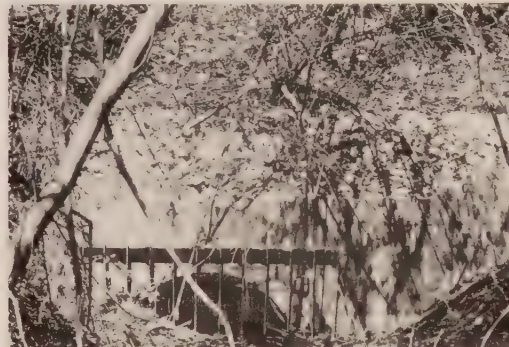
Entrance

Top of headwall deeply scaled. Many efflorescent covered cracks exist on rest of exposed wall.

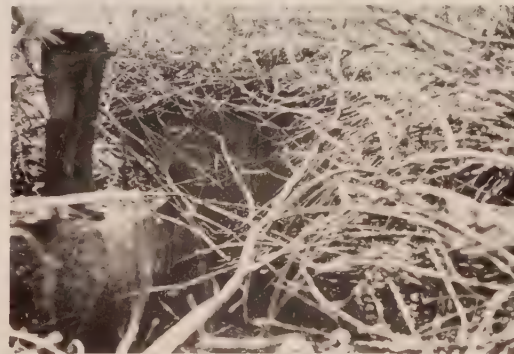
Exit

Headwall appeared in good condition. Left wingwall was undermined, heavily cracked and ready to fall apart. Right wingwall was half missing and rest was mostly fractured concrete.

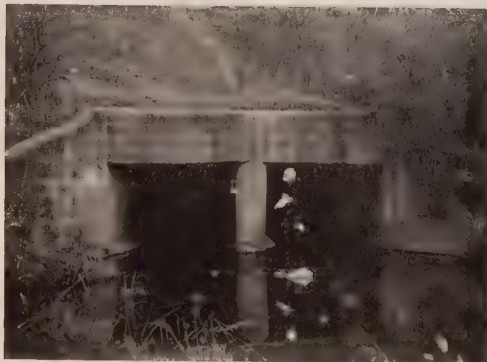
Entrance

Headwall and wingwalls in good condition. Some spalling on bottom front of center pier wall. One 6" deep spill on left wingwall along a vertical construction joint. No cracks noted.

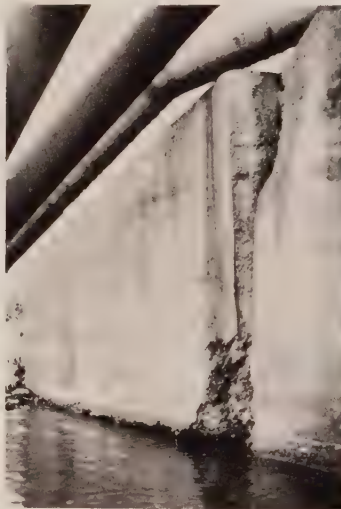
Exit - East Wingwall

Top of wingwall has moved inward 1'

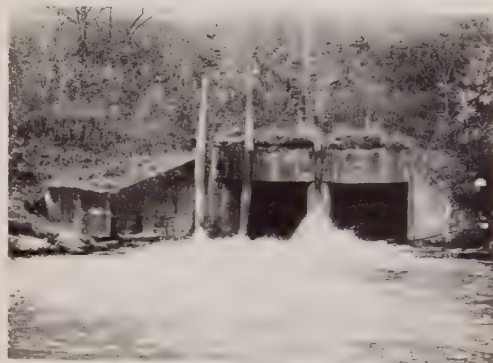
Exit

Headwall has scaled in center area. Low end of right wingwall has scaled away 1" deep and bottom 3' was all cracked. Three 10" syphons flow from canal.
